REPORT OF INVESTIGATION

Fatal Powered Haulage Accident
July 18, 2007

Pit #40 Waterloo
Lyman-Richey Sand & Gravel Company
Waterloo, Douglas County, Nebraska
Mine I.D. No. 25-00245

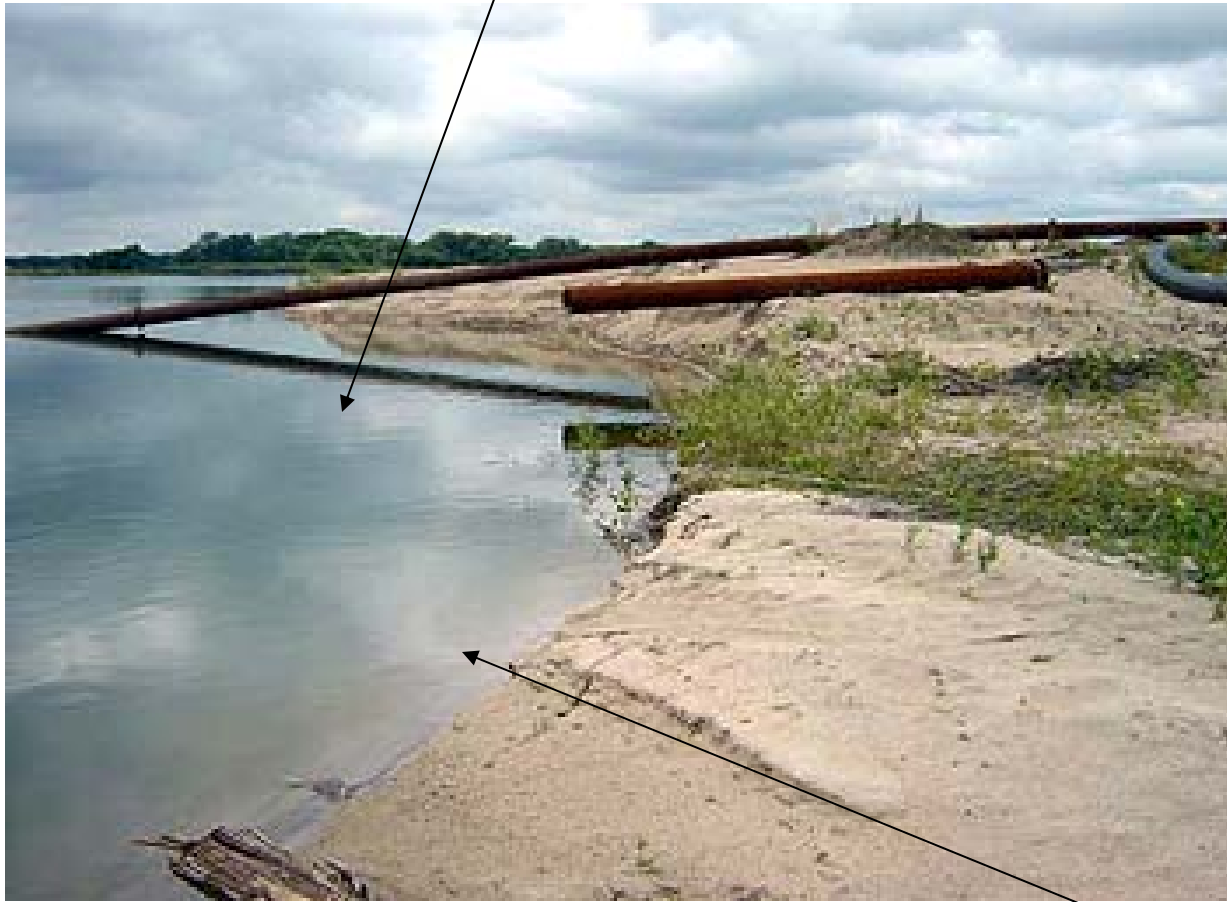
The loader turned nearly 180 degrees with the front facing the water, prior to the bank failure

Loader traveled in reverse along this route

Tire tracks on the perimeter of the largest failure scarp suggested that the loader involved in the accident was approximately 50 to 60 feet away from the pre-failure shoreline at the time of failure. Based on a description of the maneuvers made by the loader and the orientation of the tire tracks, it appeared the loader was operating generally perpendicular to the pre-failure shoreline and was facing southeast toward the dredge pond. At the perimeter of the failure scarp, the loader was operating approximately four feet above the ground water table and the corresponding zone of saturated sand.

The failed area was delineated by three arc-shaped failure surfaces. Each surface was characterized by a distinct failure scarp. The largest scarp was located in the area where the victim's loader had been operating. The two smaller scarps were located immediately to the west of the largest scarp. The largest scarp represented the initial stage of the failure. The two smaller scarps represented subsequent failure stages, occurring in conjunction with the loss of lateral support caused by the initial failure stage.

The load applied to the bank by the victim's loader and the supported section of pipeline caused the failure. This load caused the loose, hydraulically-placed sand to consolidate, extending into the shallow zone of saturated sand. The maneuvering of the loader likely created a zone of excess pressure that resulted in a loss of shear strength, causing the bank to fail under the sustained load.

Corrective Action: Procedures should be established to ensure that persons can work safely near the dredge pond. The stability of tailing deposits should be determined before persons travel or work in these areas. These procedures should be posted and discussed with all persons working at the dredge pond.
